# Ryobi VC120 Rubber Seal Replacement

This guide will help you replace the seal in the nose of the Ryobi VC120 vacuum cleaner.

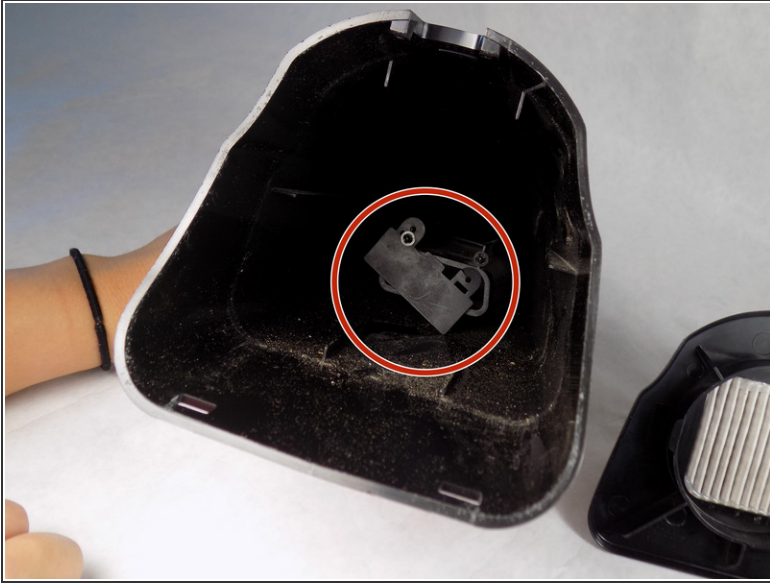
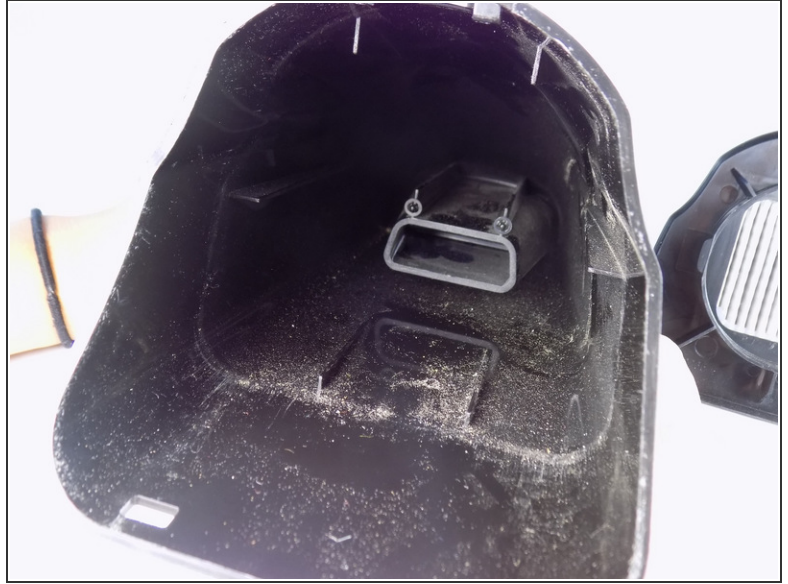
## Step 1 — Rubber Seal

- Remove the nose of the vacuum and gently pull off the rubber seal by hand.

⚠ Be careful replacing the seal on the posts, if you are too rough it may tear.

To reassemble your device, follow these instructions in reverse order.
